# Fracture of A Semirigid Penile Prosthesis: MRI Findings and Review of the Literature

İdil Güneş Tatar<sup>1</sup>, Alper Dilli<sup>1</sup>, Bahri Keyik<sup>1</sup>, Baki Hekimoğlu<sup>1</sup>

<sup>1</sup> Ankara Dışkapı Yıldırım Beyazıt Eğitim ve Araştırma Hastanesi

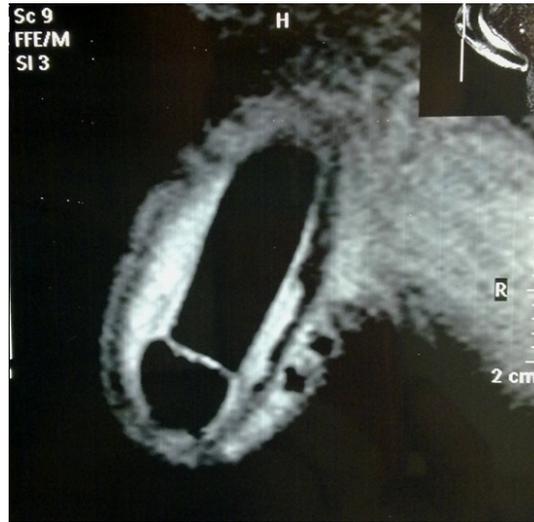
**Figure 1**  
Semirigid Pen

In 1.5 T MRI (Philips, Achieva, The Netherlands) corpus cavernosa had low signal intensity on T2-weighted images due to silicone component of the prosthesis. In the left corpus cavernosum the prosthetic material showed angulation and discontinuity, subcutaneous hemorrhage was also detected (Figure 1). Associated injuries in the corpus spongiosum or urethra were not present. The patient was treated conservatively. The deformed implant in the left corpus cavernosum was replaced with a new one five months later.
